DMF failure diagnosis – visual inspection.

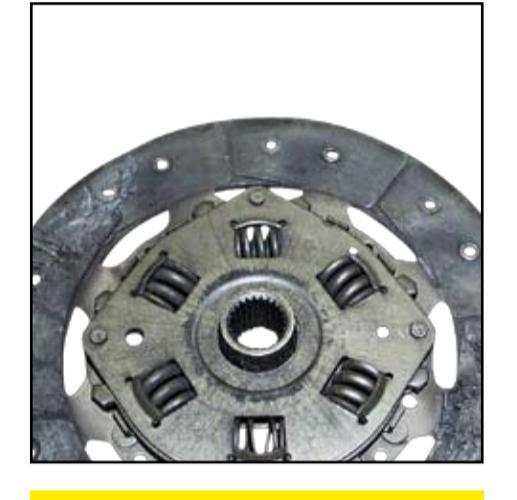
In-between primary and secondary flywheel

DESCRIPTION • Clutch disc burnt

plate, occurring e.g. if the wear limits were

• Thermal overload of the clutch driven

• Thermal load applied on the DMF

exceeded

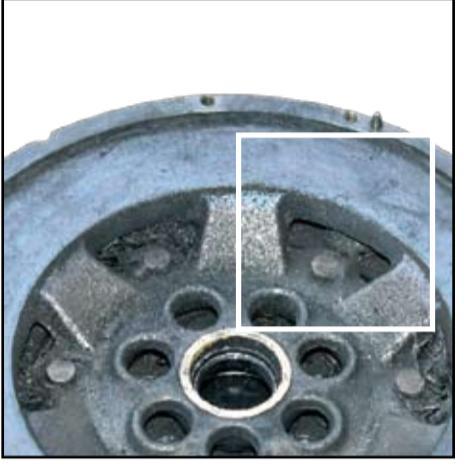
Friction surface

DESCRIPTION • Burnt residues of abraded clutch facing at • Scoring the DMF's outer edge or in the ventilation hole

• Thermal overload of the clutch driven plate

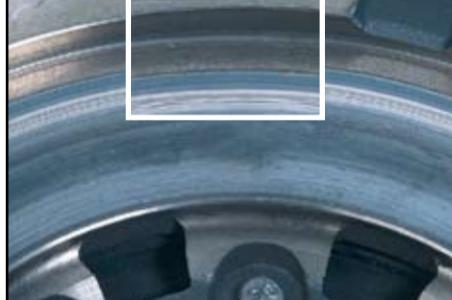
Thermal load

• (DMF subject of thermal load)

• No remedial measures required

• Localised, dark hot spots

None

→ sometimes in large numbers

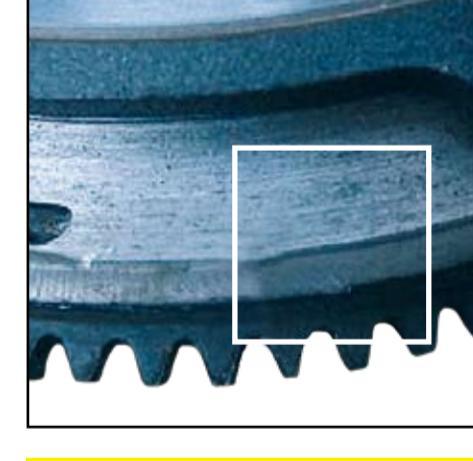
DESCRIPTION • Secondary flywheel scores on primary flywheel

Noise emission

REMEDY • Replace DMF and clutch

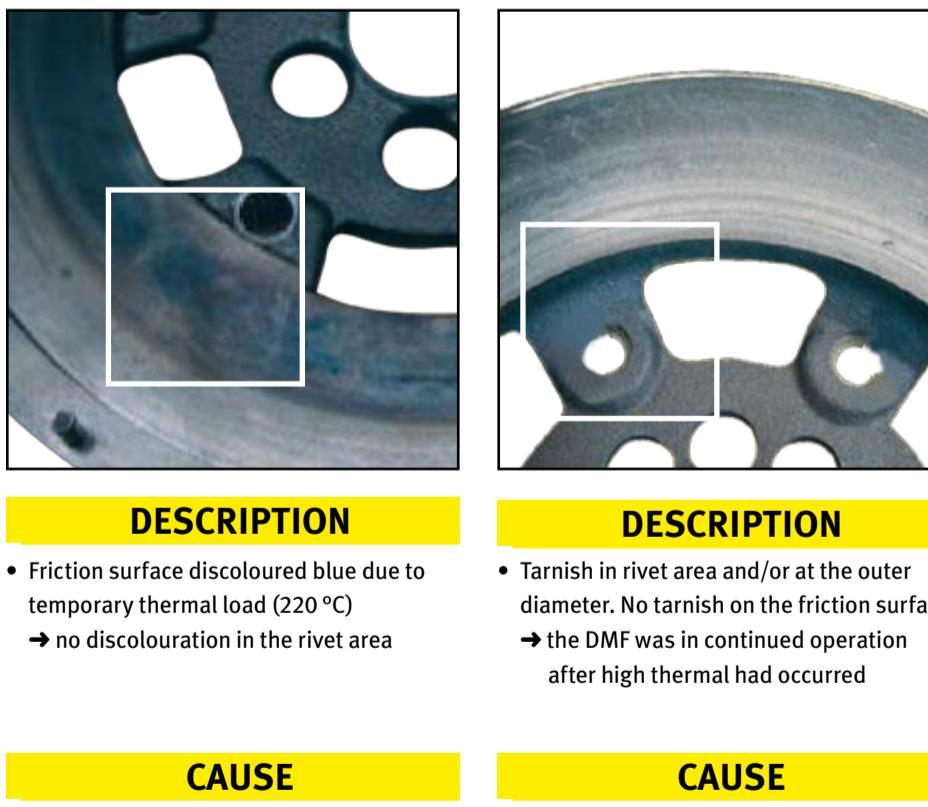
Mean thermal load

• Discolouration of the friction surface is a normal occurrence during operation

None

REMEDY • No remedial measures required

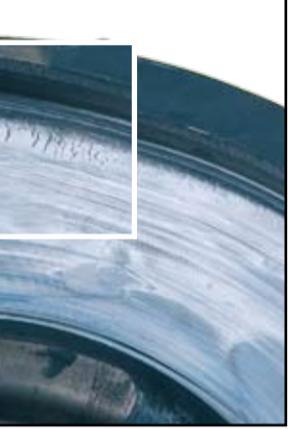
Bearing seized

Sealing cap missing or discoloured

• Thermal overload or mechanical

Insufficient bearing lubrication

damage / overload

brown due to thermal load

EFFECT • Loss of the DMF's operational reliability

→ DMF fails

> REMEDY • Replace DMF and clutch

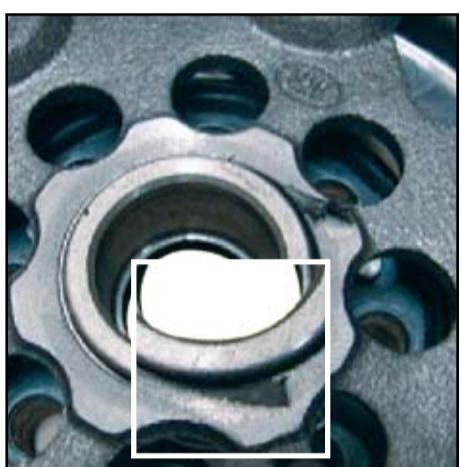
Plain bearing

DESCRIPTION Damaged or destroyed

CAUSE • Wear and / or mechanical impact

EFFECT • DMF is defective

REMEDY • Replace DMF and clutch

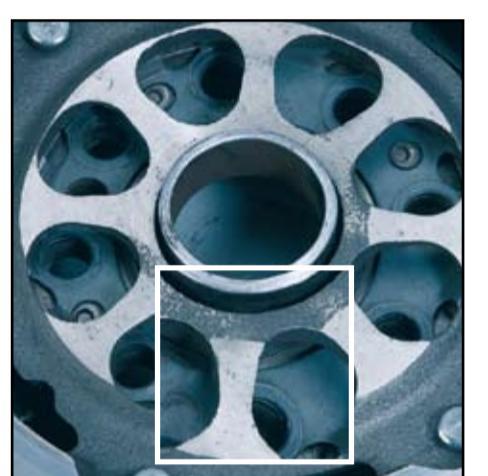
Plain bearing

Worn out \rightarrow in relation to the diameter, the maximum radial bearing clearance for a new part is 0.04mm with an admissible increase throughout its service life up to 0.17mm

CAUSE Wear and tear

EFFECT • ≤ 0.17mm: None • > 0.17mm: Increased tilting of the

second flywheel

• Replace DMF and clutch if bearing clearance • No remedial measures required exceeds 0.17 mm

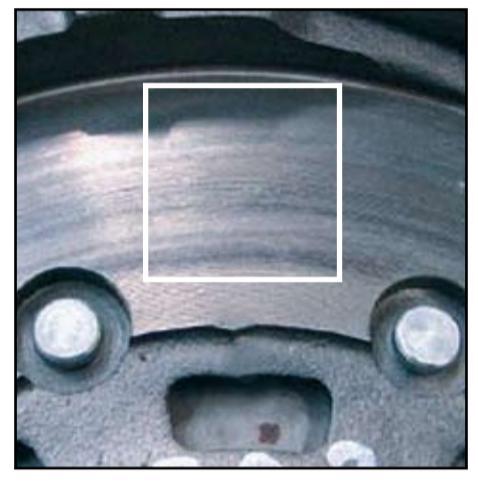
Low thermal load

DESCRIPTION • Friction surface slightly discoloured (gold / yellow) \rightarrow no tarnish at the outer edges of the DMF or in the rivet area

• Thermal load

None

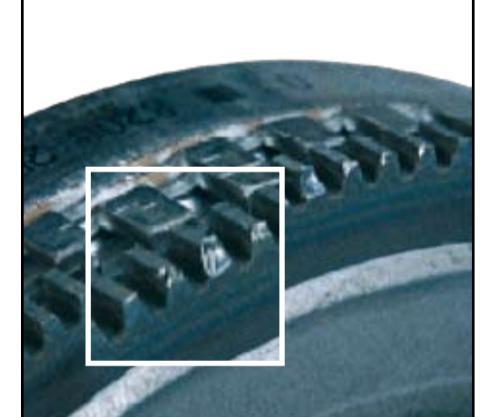
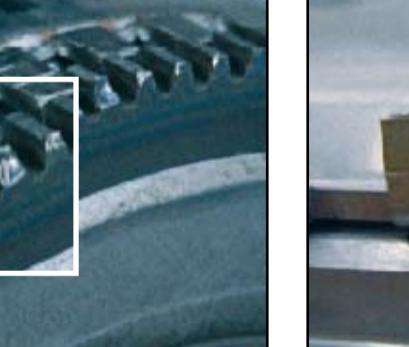
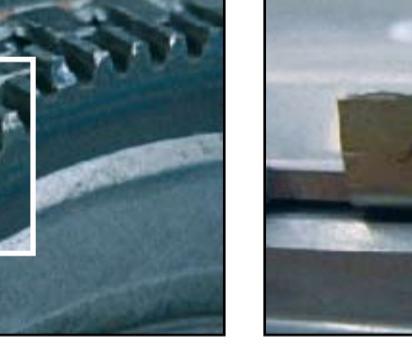
DESCRIPTION Starter ring gear heavily worn

EFFECT • Noise occurring during engine start

REMEDY • Replace DMF and clutch Perform starter function test

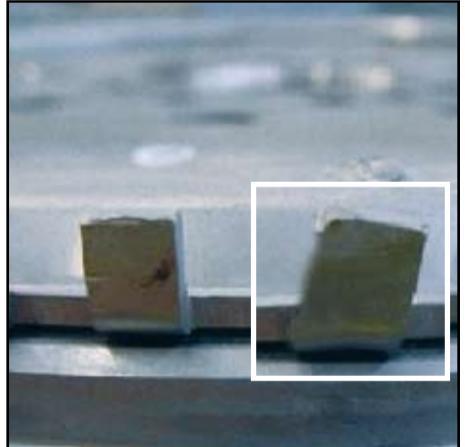
DESCRIPTION • Sensor ring teeth distorted

CAUSE Mechanical damage

• Engine runs unevenly

• Replace DMF and clutch

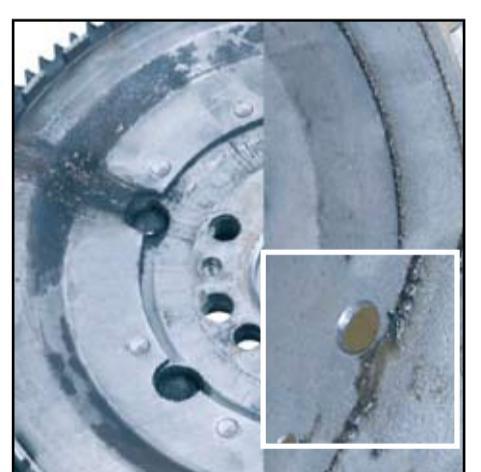
Grease egress

• Minor grease egress → slight trails of grease leaking from the openings or seal caps • Heavy grease leakage 20 g

- → housing covered with g rease
- CAUSE • Owing to design small of amounts of grease egress is allowed

• None for minor grease egress • Insufficient lubrication of the arc springs caused by heave grease leakage

• A little grease egress requires no further action

• Replace DMF and clutch if grease leakage is heavy

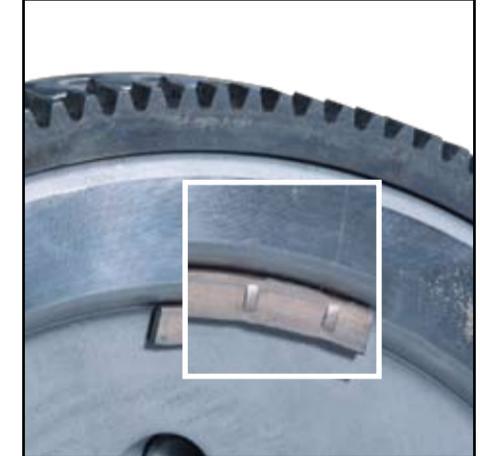
Balance weights

Loose or missing → indicated by clearly visible welding spots

Incorrect handling

- DMF out of balance → loud humming
- REMEDY
- Replace DMF and clutch

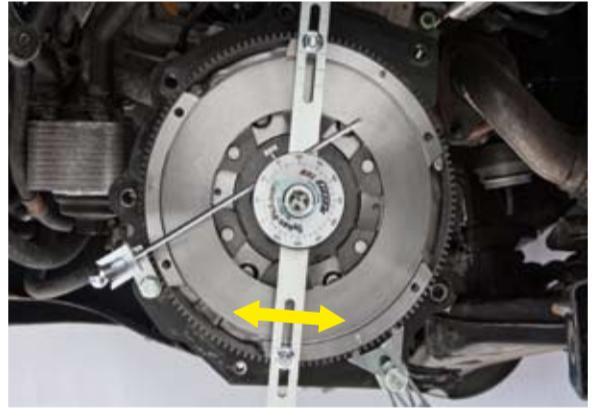
Measuring freeplay angle

A 100% functional test of the DMF includes, among other things, a test of the arc springs' characteristics during compression. This test must be performed at a special test facility as it cannot be carried out with standard workshop equipment. However, the LuK DMF special tool 400 0080 10 allows repair professionals to perform the most important measurements freeplay angle and rock – in a workshop environment.

The freeplay angle is the angle at which the DMF's primary and secondary masses can be rotated against each other until load is exerted on the arc springs. Rock occurs when the rotably supported masses of the DMF are tilted towards or away from one another.
